HO-32
District #5

Oakland Manor Barn Robert Oliver's Carriage House

_Title Reference: Map 30, Blk 20, p. 303 5-96-559 itle Survey: Howard County Historic Sites Inventory

OAKLAND MANOR BARN

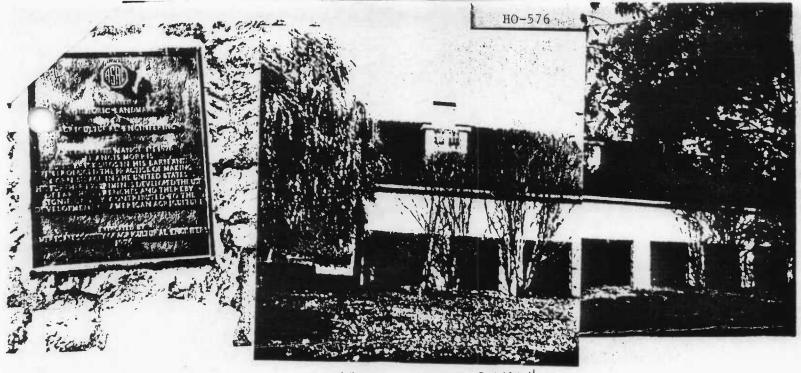
LAKE VIEW - SOUTH

A central rectangular double south entrance door is set into a recessed Roman arch, which was originally open, but now is closed. A one lite circular window rests above the entrance and is decorated with ashlar stretcher stones along its circumference. A full arched stone lintel decorates the recessed arch, while a horizontal rectangular one lite casement window flanks each side of the circular window and a first floor vertical rectangular one lite casement window with flat arched stretcher stone lintel lies on each side of the central north entrance.
